Aylsham & District u3a Historical Buildings Group

Report on

Barn to rear of 1 Market Place

(on Bank Street)
facing onto
Norwich Road
Aylsham

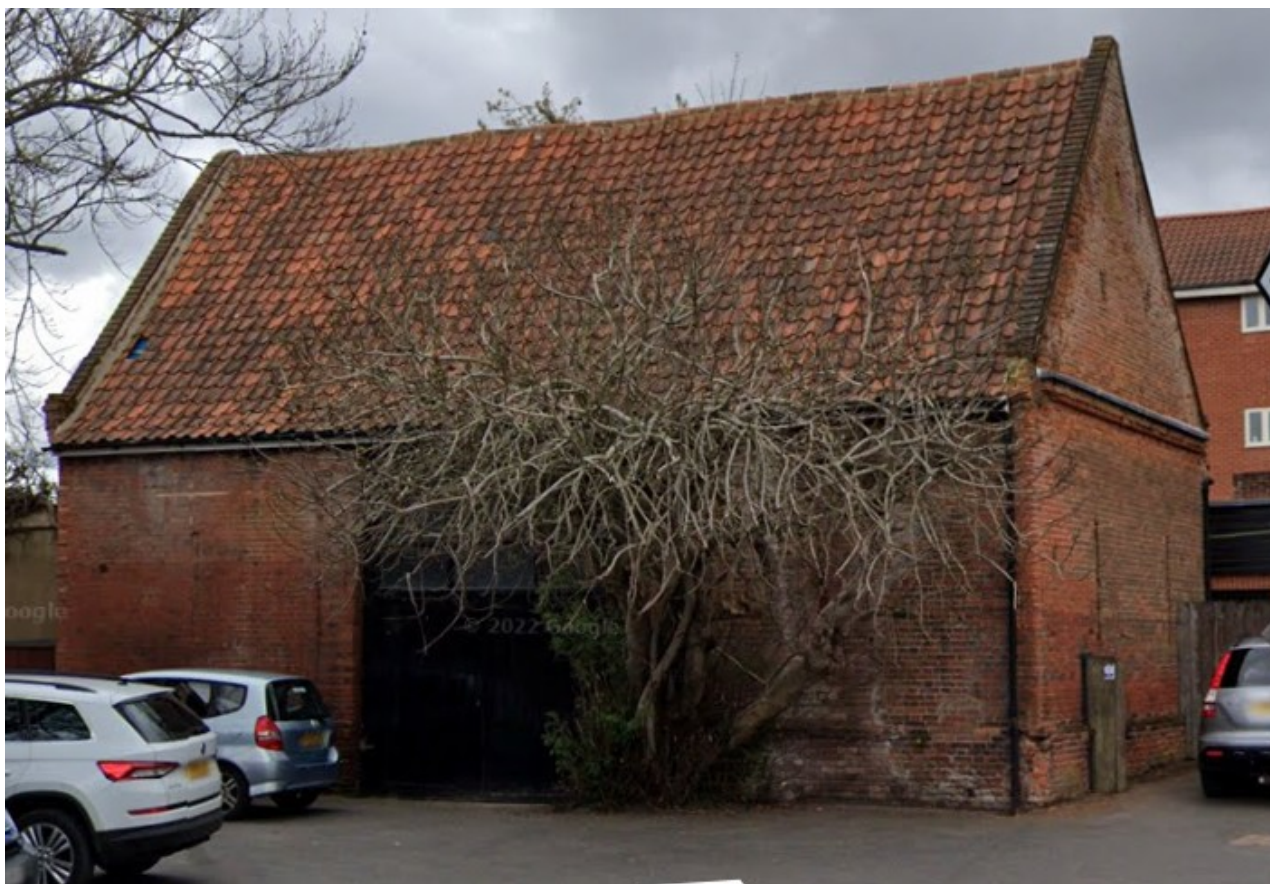
East side (facing Norwich Road)

Note colour change where the dark red bricks suddenly change to a more orangey red part way up.

As can be seen in the main picture at the start of the report, the bricks change colour part way up the walls. This is the case on all four sides but the changeover height differs on each side, suggesting the changeover was not deliberately designed in.

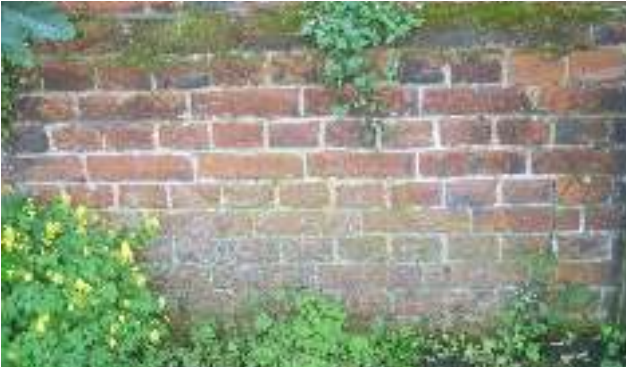
English bonded brickwork to plinth – alternating courses of brick sides (stretchers) and brick ends (headers).

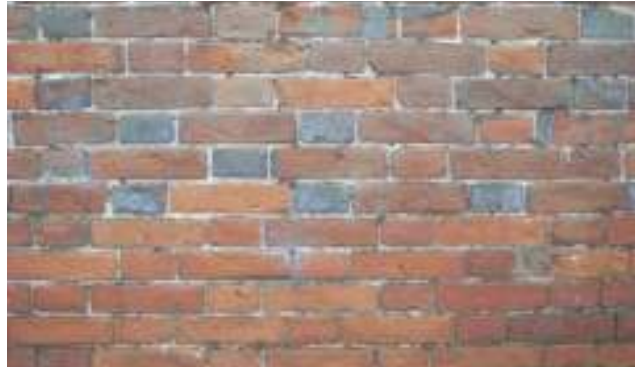
Flemish bonded brickwork to walls above plinth – alternating stretchers and headers in every course.

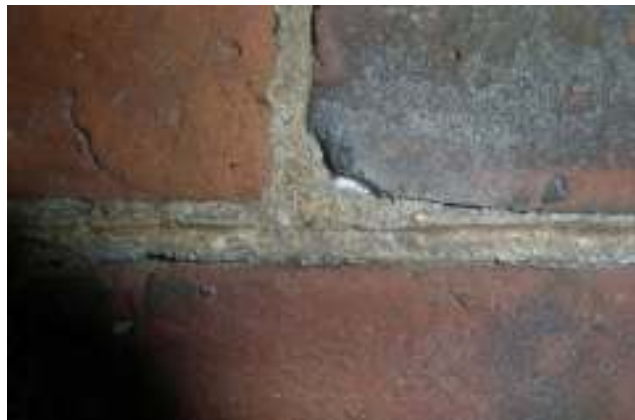
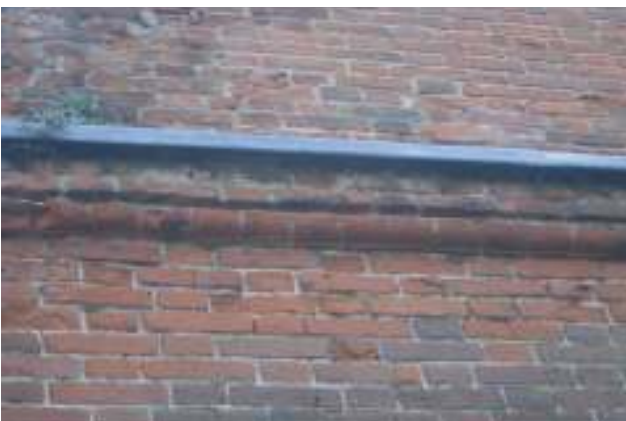
Where the original mortar finish has survived, the horizontal joints have been given a 'ruled' finish – this is a rounded horizontal indent running along the mortar joint (see picture to the right). The indent is applied with a special tool and was normally reserved for high class work – it subtly altered the visual appearance of the joints. Note how only the horizontal joints have been 'ruled', the vertical joints were often also ruled on high class houses. The fact that a ruled mortar finish has been used on an 'agricultural' building suggests the more fashionable Flemish bonded brickwork could have been used soon after its introduction around 1700.

To the left is part of the moulded brick platt band at the base of the north gable (unfortunately the top moulding has been covered by an inappropriate lead canopy). The platt band is identical to that on the side of the 'Black Boys' in the Market Place (which has been 'dated' to 1710), and also those on the north and west sides of the 'Old Bank House' on the opposite side of Norwich Road – which has been confusingly assigned several dates in the Norfolk Heritage records.

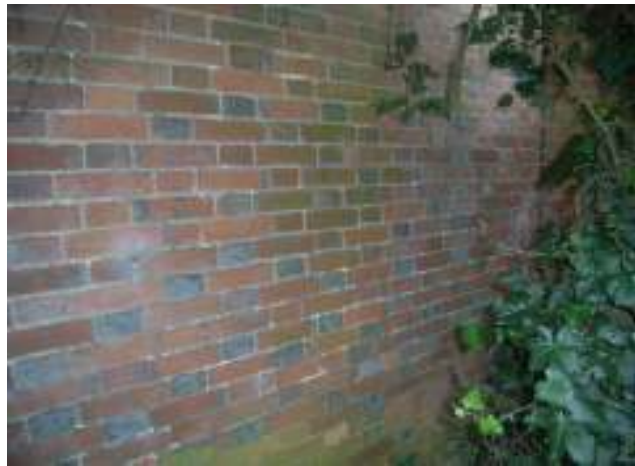
There is a high proportion of 'blue headers' in the darker red sections. These are produced when the bricks are 'over-fired' so they begin to vitrify – this can be accidental or deliberate. The 'over-fired' bricks are much more resistant to weathering than normal bricks and are also stronger. In places the blue headers appear to have been deliberately chosen and laid to create a pattern, this is particularly noticeable on the west side as shown on the right. This type of pattern was fashionable pre-1700 but was rarely used after then until the late 1800s. There are some 18th century houses in Aylsham that possess small areas of blue headers to create a similar pattern, but these patterns appear to be 'accidental' – one such house on Hungate Street is dated 1765 but the brickwork appears to be later than the barn.

There is subtle change of brick size between the darker reds and more orangey reds. In both cases the bricks are 2¼” tall but while the darker bricks are 9” x 4⅛”, the orangey bricks are 9⅛” x 4¼” – suggesting they were produced by a different brick-maker.

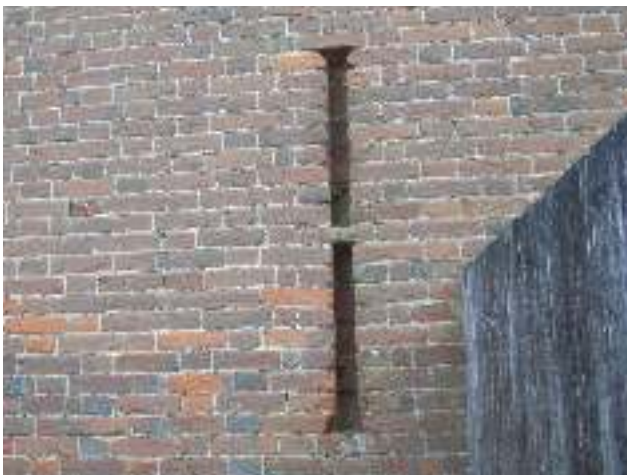
Blocked ventilation opening on north wall – carefully blocked from inside using bricks laid on their sides and bedded in lime mortar, suggesting late 19th century work

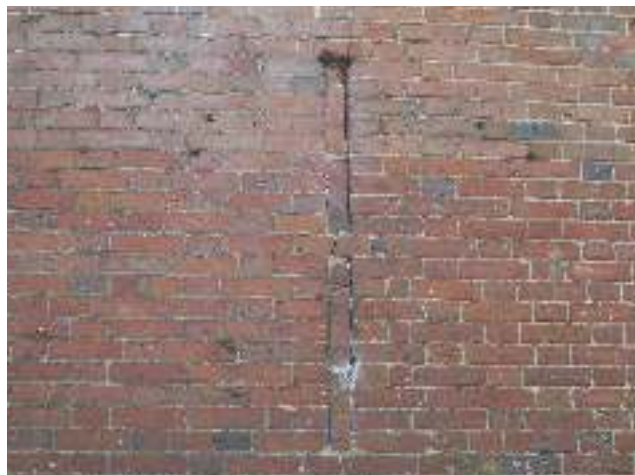
Blocked ventilation opening on east wall – crudely blocked from outside by stuffing space with upended bricks secured with minimal lime mortar, suggesting inter-war work

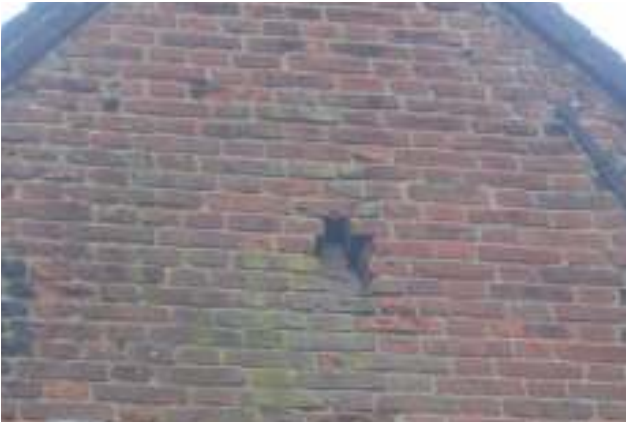
Blocked ventilation opening on north gable – crudely achieved by covering the opening internally with modern building materials, suggesting circa 1970s work

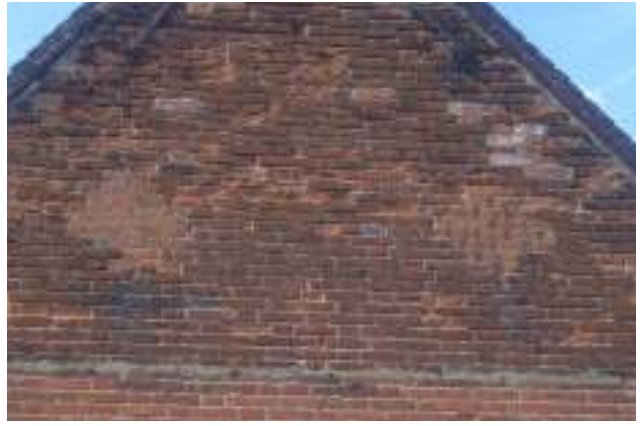
Blocked diamond pattern honeycomb ventilation openings on south gable – closed off by inserting additional bricks into the honeycomb openings using cement mortar, suggesting done circa 2000

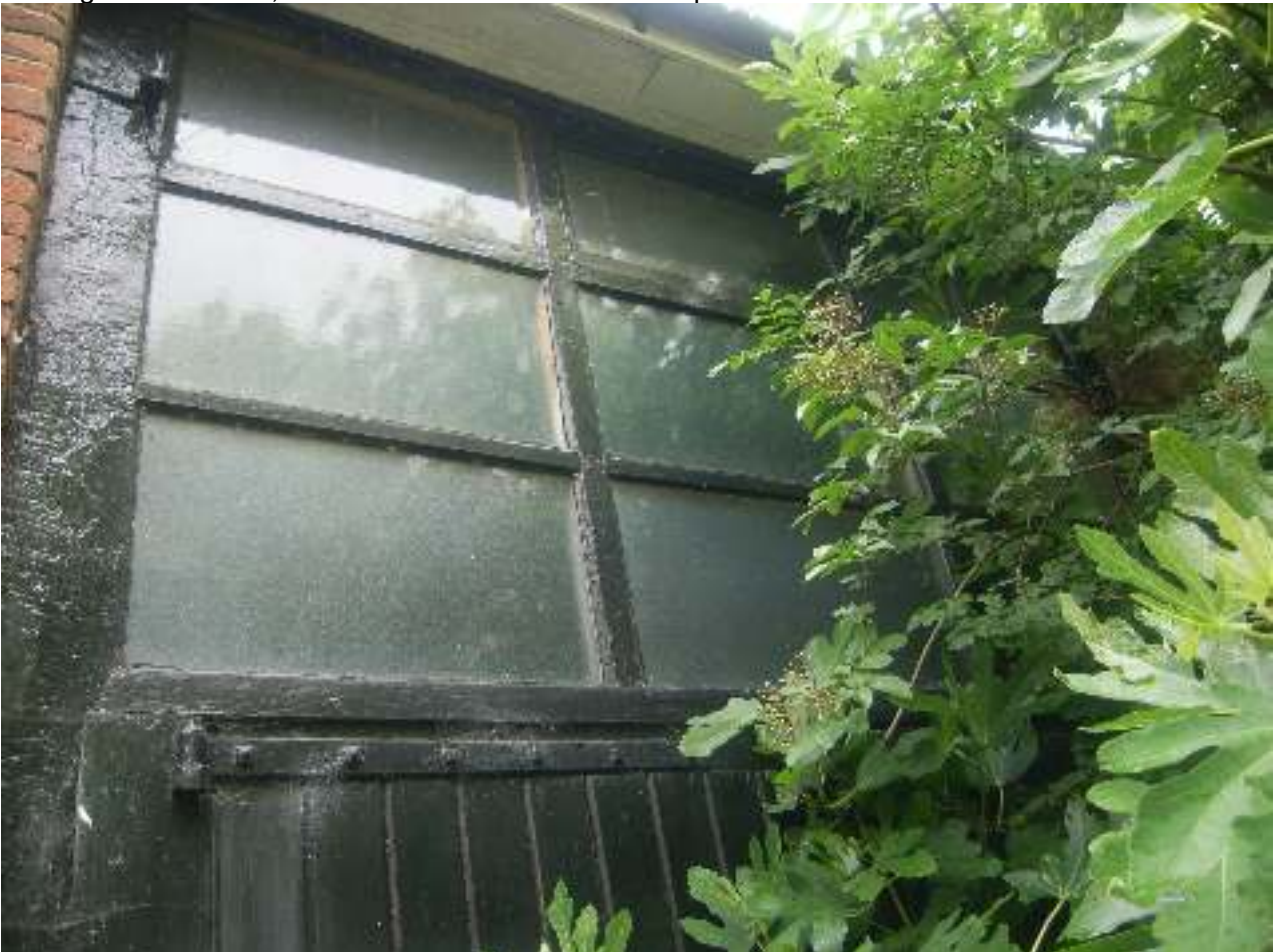
The original door frame for the cart doors (with the top hinges) is still present to the sides of the original opening. A simple timber frame to support the nine glazed sections has been inserted into the original door frame. The glass used appears to be pre-war and the panes are quite large, which together with the lack of mouldings on the timber sections used, suggests an interwar date – the capabilities existed for such work in late Victorian or Edwardian times but they would normally not consider it a finished job without moulding the timbers. The fitting of the personal door below the glazing is extremely crude – the side of the original door post has been cutaway (exposing the underside of the joint with the sill of the glazing) before wedging a new door post into position to hang the new door onto. This workmanship is typical of the 1970s.

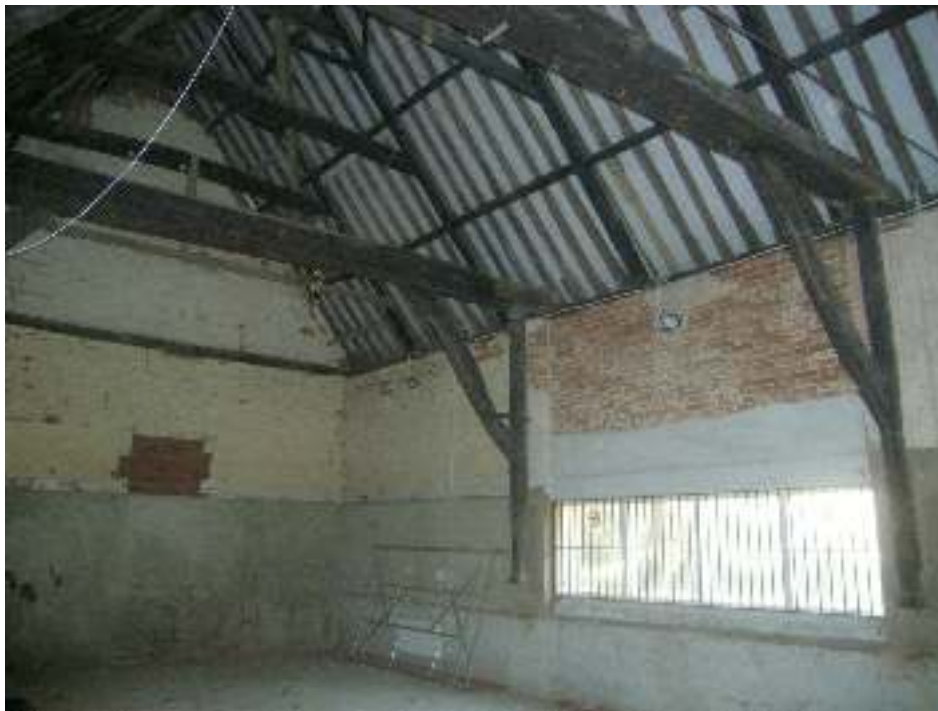
The scale of the barn interior is apparent in this picture, looking towards the south-west corner with both braced tie beams visible. The long window is set at normal modern window height!

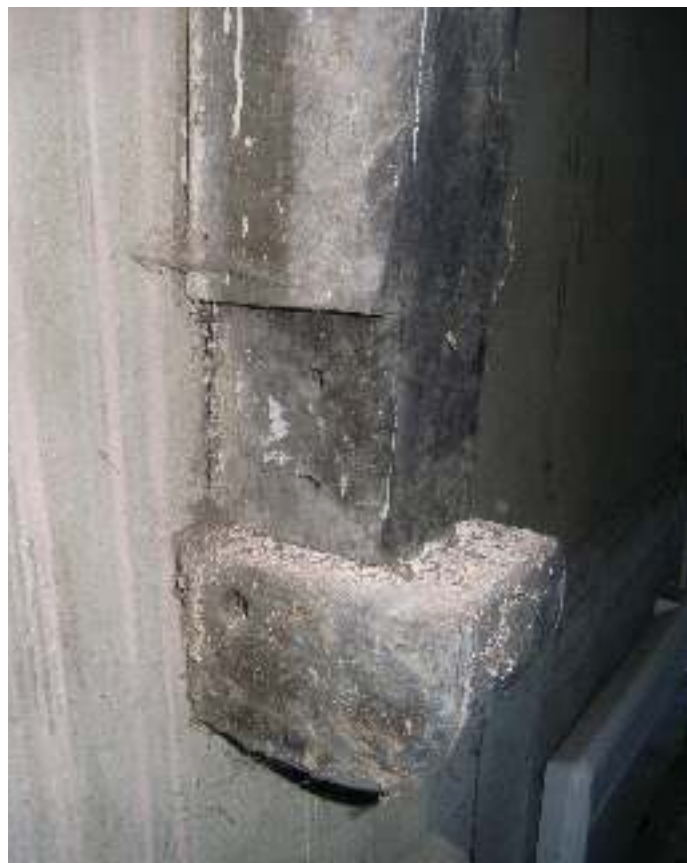
The two braced tie beam assemblies (i.e. each horizontal beam, with their two vertical end posts, two diagonal braces, and short support beams projecting from the walls at the base of the posts) are older than the rest of the building. (It was common practice to reuse parts from older buildings throughout history prior to 1900.) See the pictures below for evidence of: reuse from an earlier barn; chamfered edges with run out 'stops'; and joints all inscribed with a full set of carpenters marks. From this we can infer that they were originally made in the late 17th century.

Foot of a braced tie beam showing that the vertical post was originally part of a different building

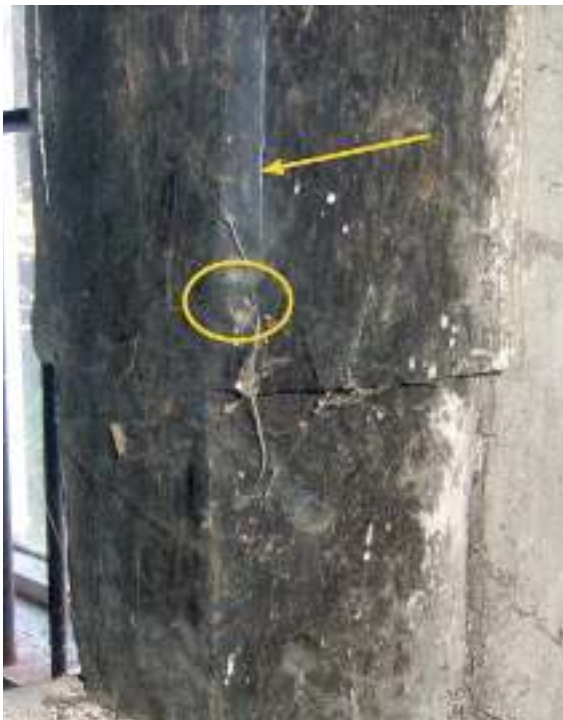
Chamfered edge (arrowed) with run out stop (circled) at bottom

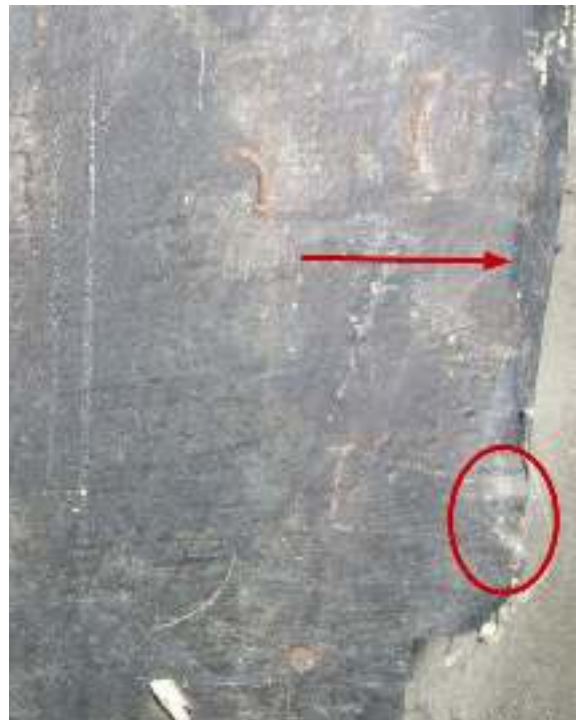
Another view of chamfered edge (arrowed) with run out stop (circled) at bottom

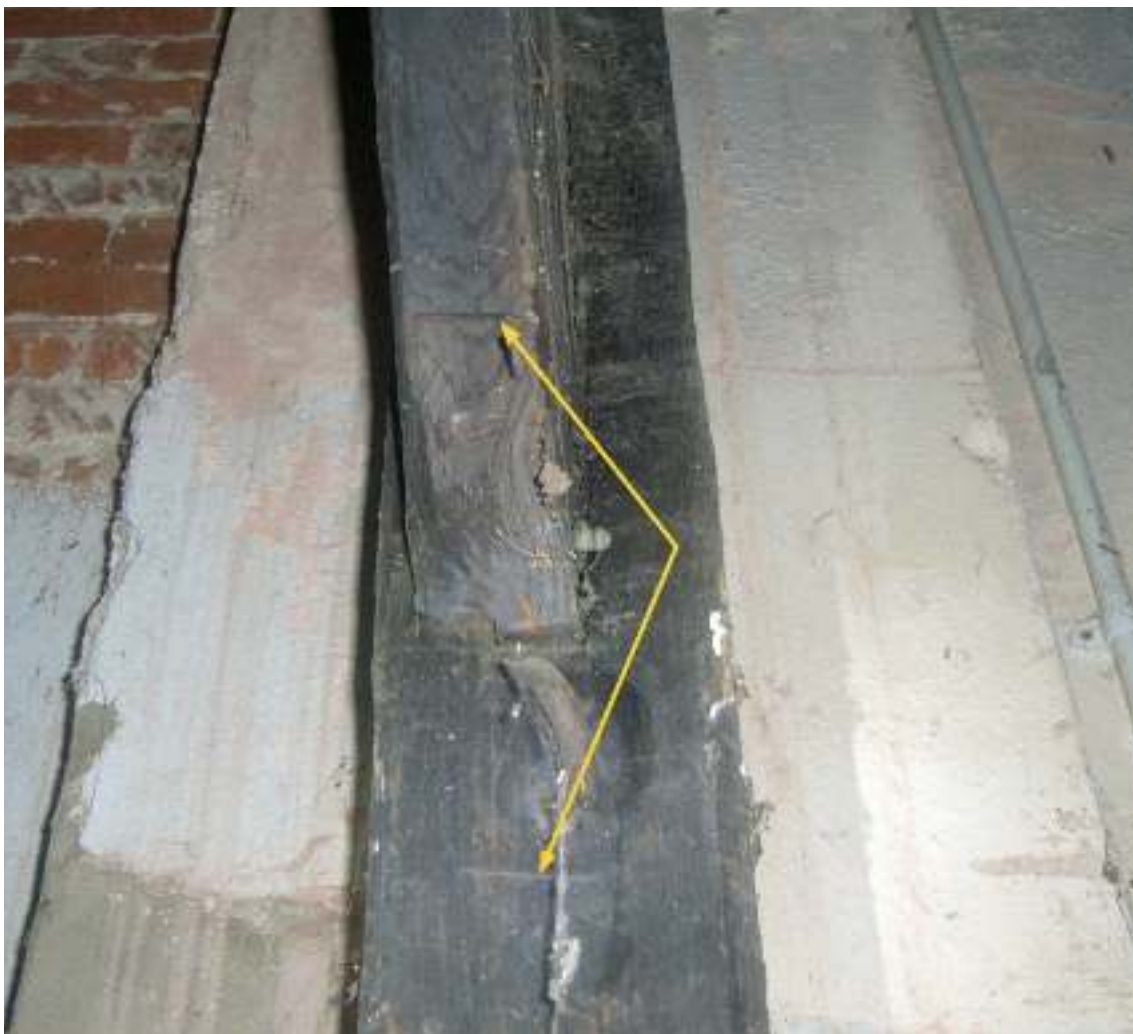
Carpenters marks (arrowed) – in this case for joint number 1. The two stopped chamfers can also be clearly seen on both edges of the post below the joint and can also just be seen on the bottom of the brace – although not visible in this photo, a separate pair of stopped chamfers start on the post just above this joint, and the tie beam itself has matching chamfers albeit larger.

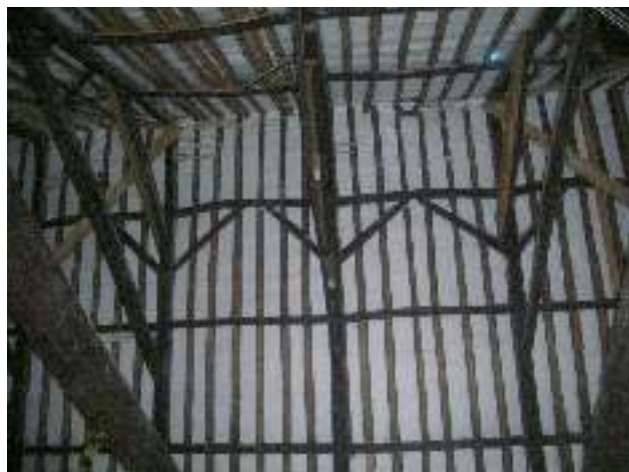
The roof structure possesses regularly spaced trusses linked by small section horizontal beams (purlins). The purlins support common rafters and are reinforced with diagonal wind braces. Stylistically, this is a 17th century design but in this instance, the common rafters are simply halved poles of varying diameter along their lengths and their slenderness means they have to be very closely spaced – these halved poles are much too crude for 17th century work but are typical of 18th century carpentry. Wrought iron straps have been used to attach the base of the roof to the tie beams – again an 18th century technique. The roof has been heavily repaired in modern times, particularly towards its northern end.

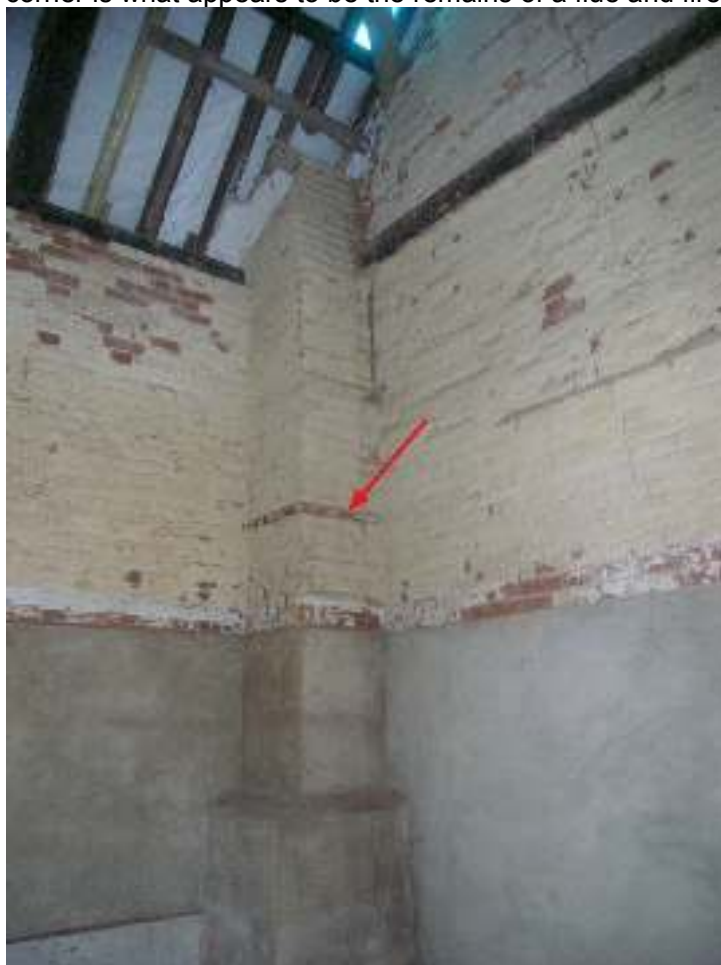
The dimensions and design are typical of mid-19th century work and the fireplace would be more suitable for a cast-iron stove than an open fire. The flue itself has been tethered to the two outside walls using a right-angled wrought iron strap (arrowed).

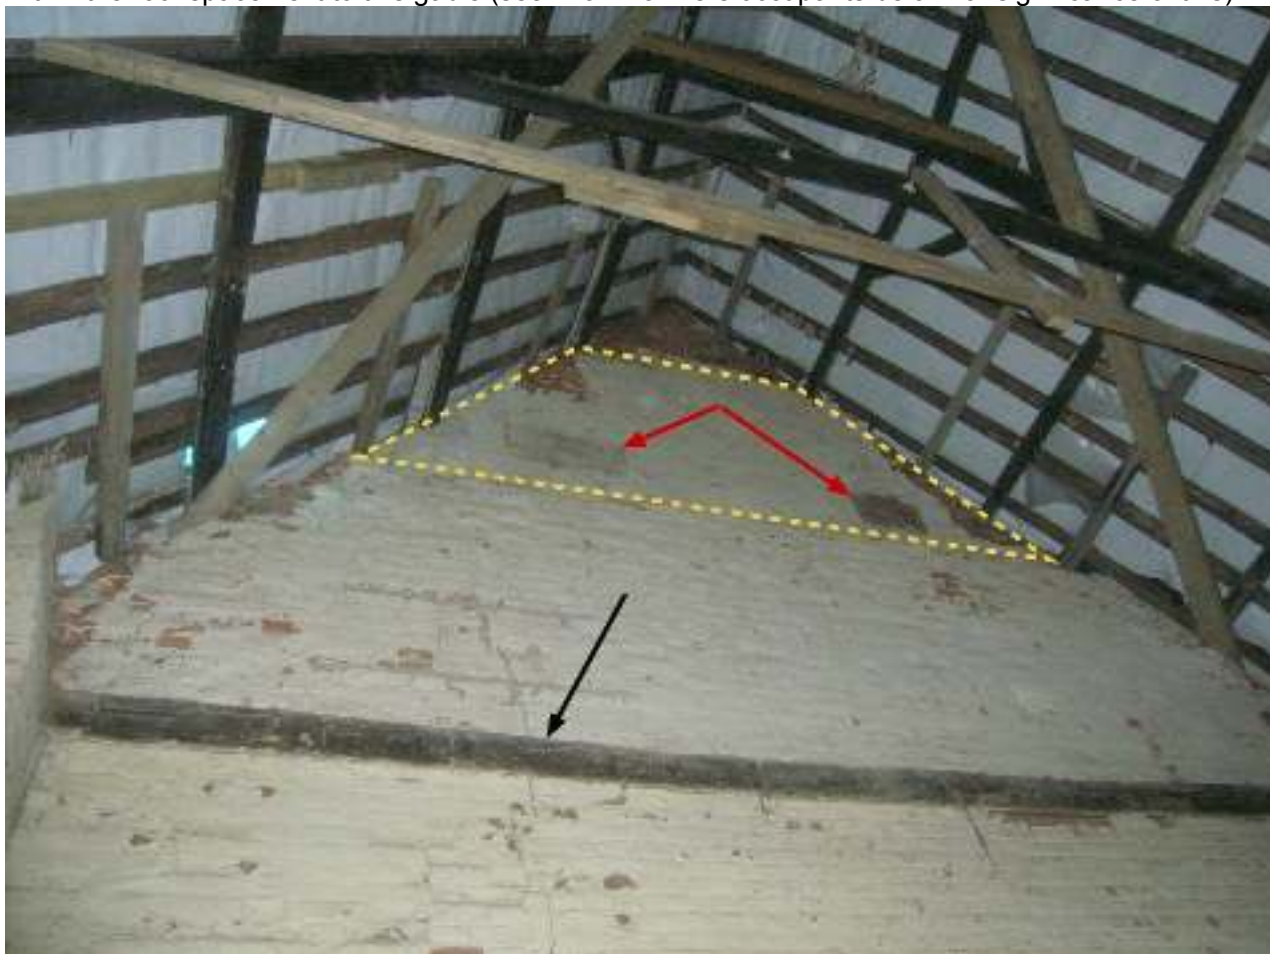
The horizontal timber (black arrow) at the base of the south gable protrudes beyond the wall face. Timbers normally only protrude like this to provide support for an upper floor – the corresponding timber at the base of the north gable is finished flush with the face of the internal brickwork as was standard practice throughout the 18th century.

The upper part of the south gable (within the yellow dashed outline) appears to be lime plastered, with the area below being limewashed down to the protruding beam. The plastered wall area is ½ a brick thinner than the rest of the wall – while this doesn't matter for a barn, if part of a room it would be routinely plastered to prevent draughts blowing through the mortar joints.

What appear to be a pair of windows (red arrows) have been blocked up – interestingly these match the positions of the blocked external diamond honeycomb vents shown on page 4 but are a different shape! This raises the possibility that high level windows pre-dated the honeycomb ventilation openings, with the internal window openings conceivably being bricked up independently of the external bricking up of the honeycomb openings.
