Aylsham & District u3a Historical Buildings Group

Report on

12-13 Market Place Aylsham

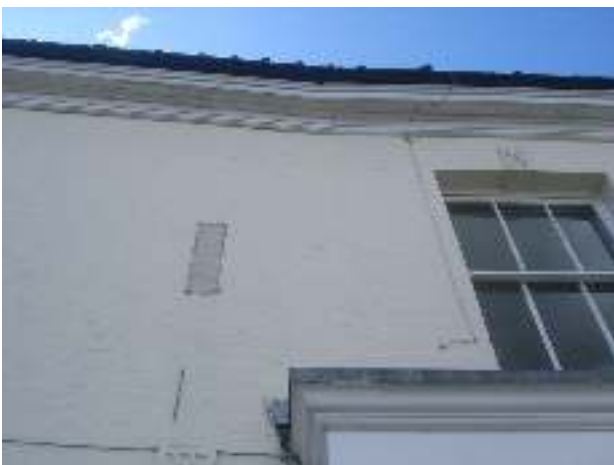
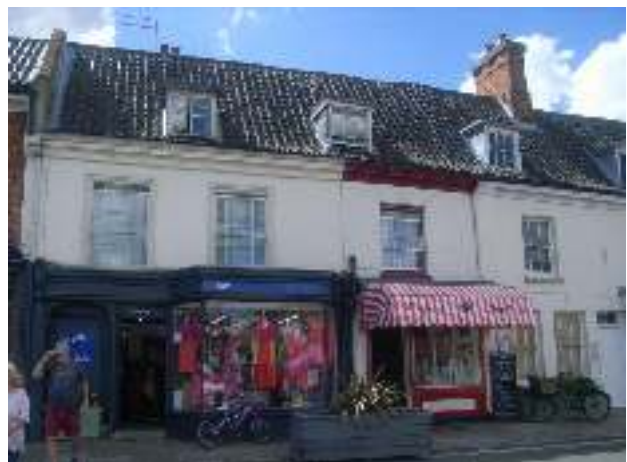
As shown below, the alignment of the building changes just above the southern end of the shopfront. Although now all one building, the change of alignment indicates we are dealing with what was originally two independently constructed buildings.

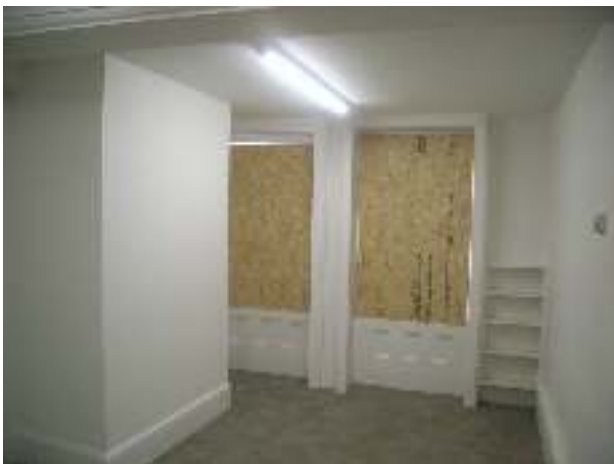
Inserted chimney backing onto the hallway that already reduces the width of the room by 6ft. This chimney matches that in the large back room within the middle rear wing. The very deep alcoves allied to a moderate breast width are typical of circa 1800 work, but in this case leave one window almost completely obscured!

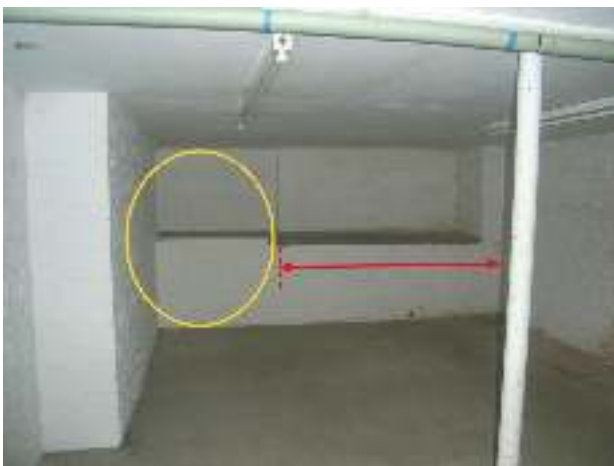
Main cellar – wall on right is against the Market Place, wall on left is no older than the external facing to the building and is covering the original (presumably decayed/damaged) back wall. Section marked in red is the base of the original chimney backing onto the northern party wall, the brickwork above the dashes has been cut away but when present, the dimensions indicate it would have supported a typical late 17th/early 18th century inglenook fireplace in the room above. The fireplace is offset to create a large alcove (circled). In buildings of this age and type, the large alcove housed the original stairs, each flight consisting of a 180° turn round a central newel post.

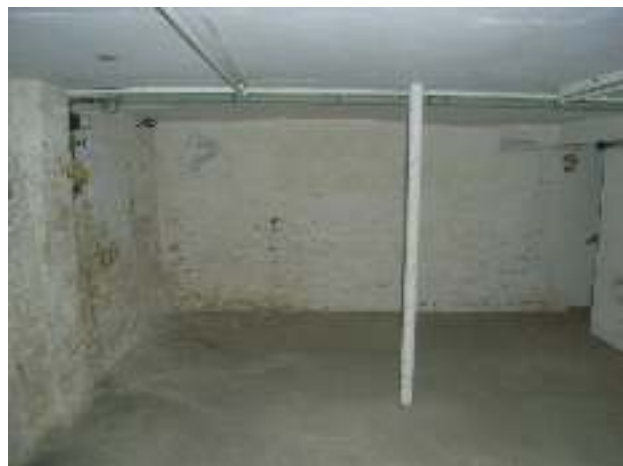
The pole has been inserted to provide additional support to the centre of a timber beam that once supported both the wall between the two ground floor rooms above, and also the floor joists to those rooms. One end of the beam sat on the projecting brick pier to the left of the picture. The timber beam has almost certainly been replaced with concrete or steel. Beyond the pier, the clean looking bit of wall is where a loading door was created in the 19th century so as to open to a trap door set into the paving of the Market Place. This has subsequently been bricked up again.

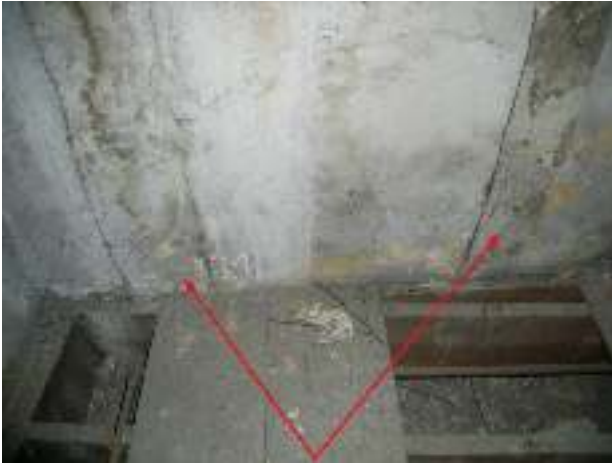
A pair of vertical timber posts (arrowed) in an otherwise brick wall. The posts mark the location of a narrow doorway from the corner of the northernmost front room – where the top of the presumed newel stairs were. For the door to be reached, the stairs must have risen in an anti-clockwise direction. A narrow door used to access a room from the top two or three steps of a newel staircase suggests the original northernmost wing was constructed shortly after the main building – say only 20-50 years later. The floor of the wing is now considerably higher than in the adjacent front room, again indicating that the wing's current floor level is the result of a later reconstruction.

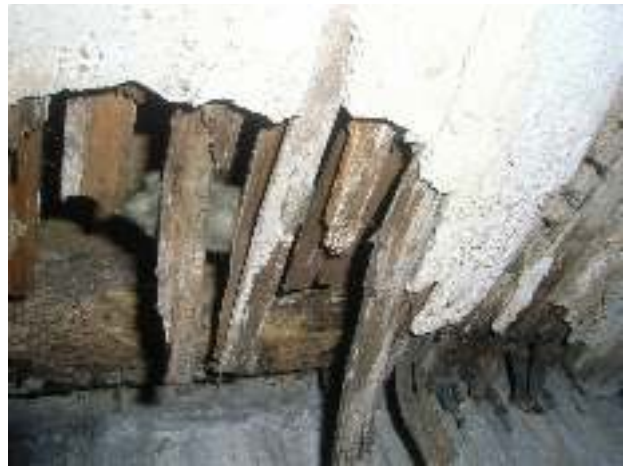
The (water damaged) plaster and lath ceiling within the cupboard. The timber laths themselves have been sawn from the original tree, marking them out as 19th century or later – 18th century and earlier laths were peeled from the tree. Although the plaster is lime it contains no hair, this is characteristic of early 20th century work.

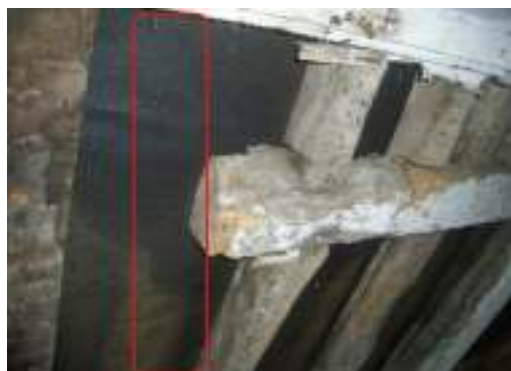
- The party wall/gable that originally separated the two roof sections has been completely removed – this used to be just a few inches to the south of the middle dormer window. Although the roof area with the middle dormer window is apparently older than that coming through from the butcher's premises, the older roof derived little or no support from the missing gable/wall so was not compromised by its removal. This suggests the older roof was built up against an already existing building when erected around 1700. By contrast, the missing gable/wall was integral to the later roof coming through from the butcher's premises. To achieve the removal, some roof timbers had their ends cut off leaving parts of the roof unsupported and ultimately leading to structural failure.

- the red outline indicates where the missing gable/wall was
- the timber to the left of the outline is the start of the earlier roof
- with the visibly truncated roof coming from the butcher's premises to the right of the outline – note how the unsupported end has dropped causing the nearby joints to break apart.

- The chimney that was built next to the inserted ground floor hall runs up through the roof section coming from the butcher's premises. This is set just a few feet in from where the supporting gable/wall used to be. To accommodate the chimney, some of the roof timbers simply had sections cut out, leaving parts of the roof unsupported... again. It is presumed this work was carried out at the same time as the removal of the supporting gable/wall.
