Aylsham & District u3a Historical Buildings Group

Report on

12-13 Market Place Aylsham

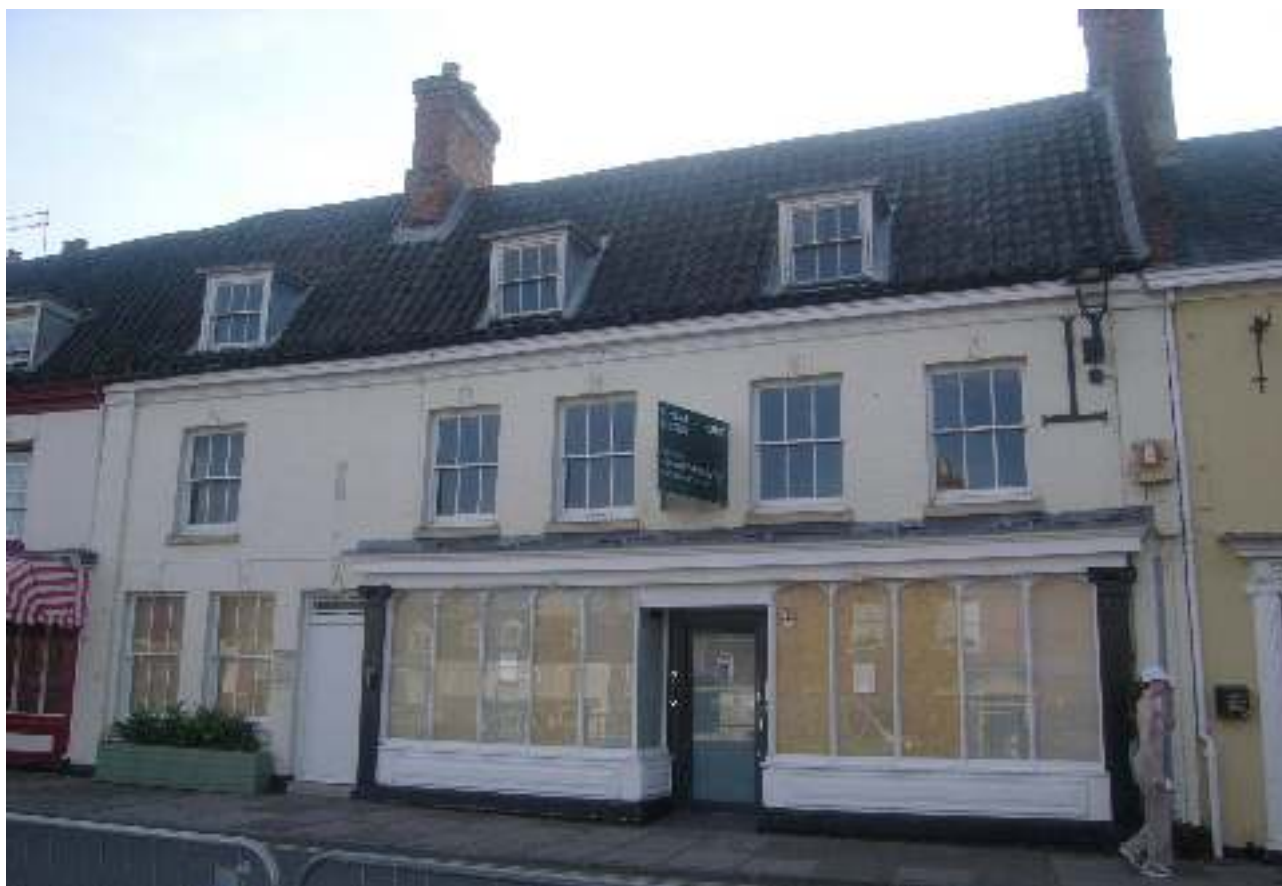
Market Place frontage

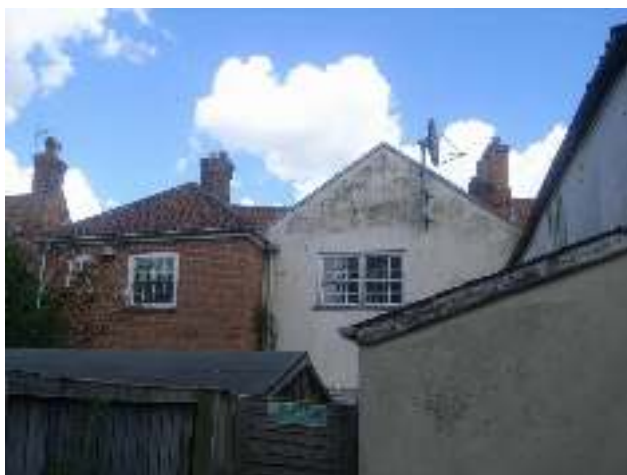
Current view of the 3 rear wings. The red brick end of the left hand wing dates from around 1990 when the wing was truncated (see aerial view). The building on the extreme right is the wing now accessed from the adjacent butcher's premises.

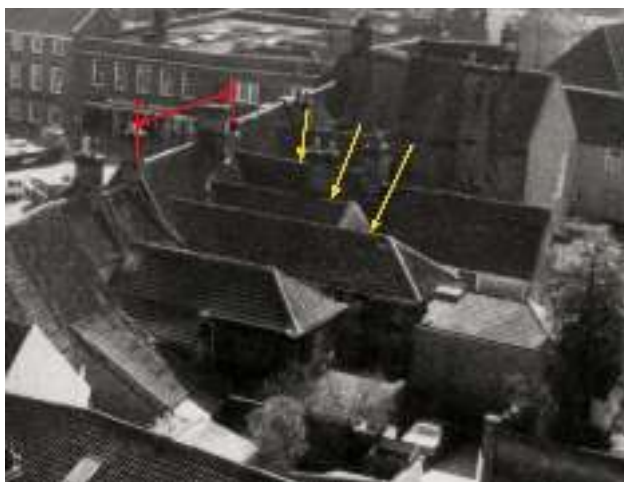
Aerial view taken in 1970s. Extent of Market Place facade marked in red. The three back wings (indicated by yellow arrows) are clearly visible, with the one closest the camera being one room longer than now.

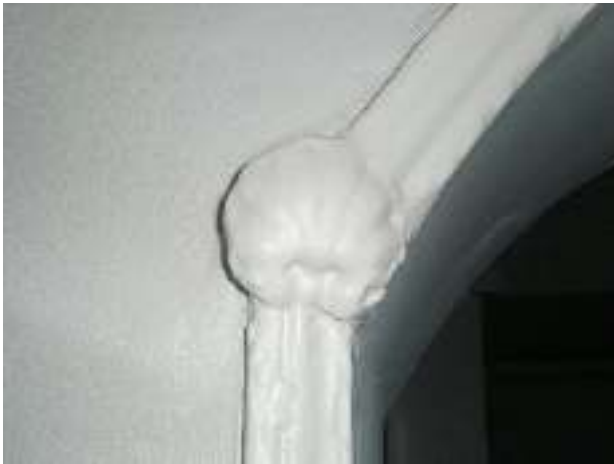
The mouldings on the arch at the end of the hallway are heavily obscured by thick paint but include shell motifs and are consistent with work from circa 1800.

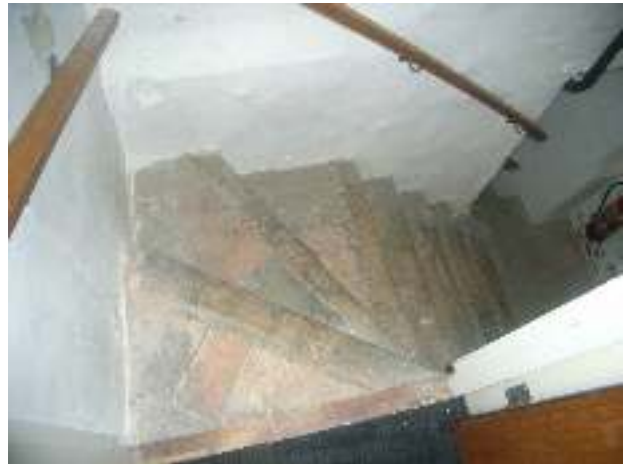
The cellar stairs were almost certainly constructed at the same time as the staircase they run under – both are consistent with circa 1800 work.

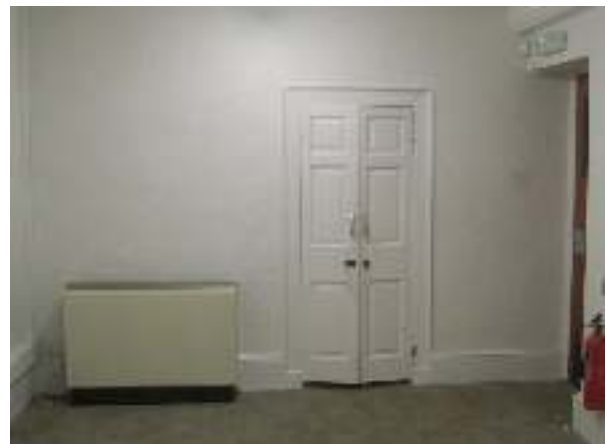
Opposite the windows of the reduced width room, a pair of double doors dating from circa 1800 once led into the southernmost rear wing. The double doors now just open into a deep storage cupboard.

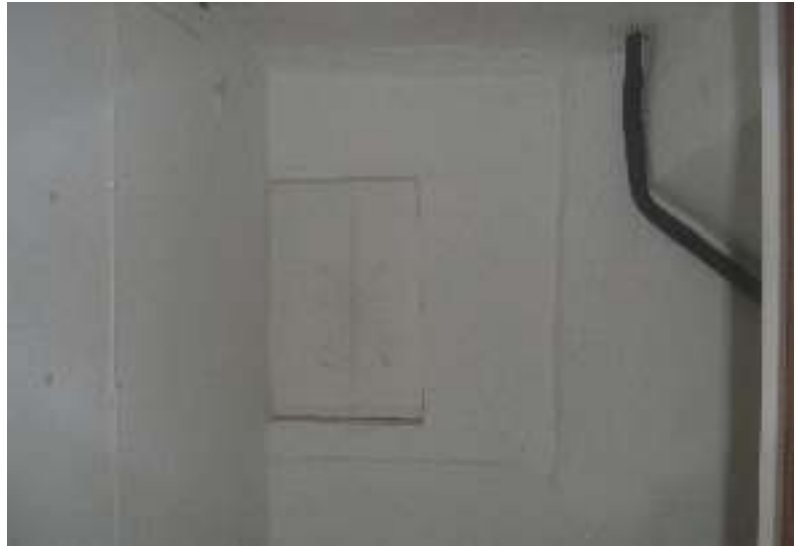
As part of the changes, a former back window in the old back wall that was affected by the new staircase was reduced in size but retained to help illuminate the cellar stairs. As can be seen in the adjacent photograph, this reduced window was later completely blocked using timber boarding – it is impossible to tell when this was done but timber boarding is unlikely to have been used for banking premises!

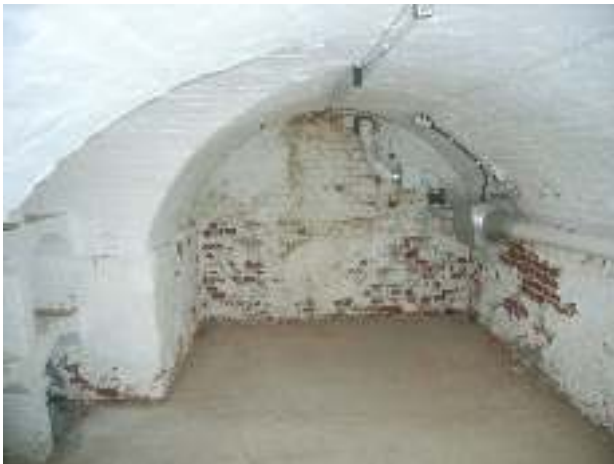
Second cellar – typical domestic scale cellar dating from the late 18th/early 19th century.

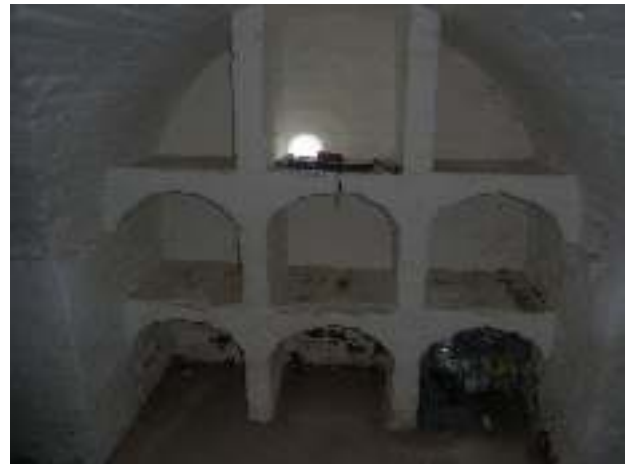
'Dairy alcove' in second cellar with cold shelves for butter, cheese etc.

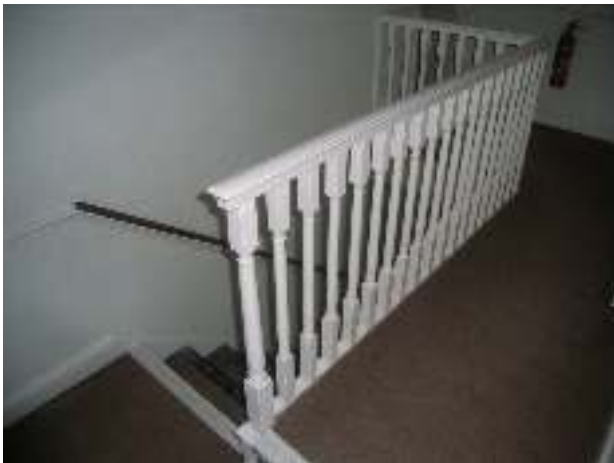
The stairs in the circa 1800 rear wing lead up to a fashionable landing designed into the layout which provides direct access to all first floor rooms.

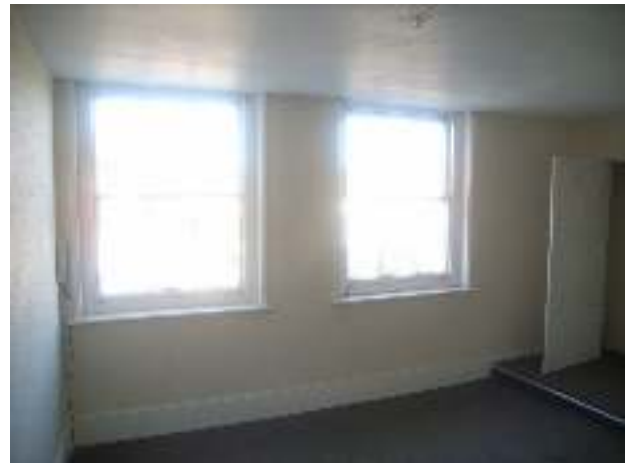
The original party wall, between what is nominally numbers 12 and 13, was removed to extend the middle front room over the hallway (created out of the southernmost ground floor room). In the above picture, the party wall used to be where the edge of the step is next to the window.

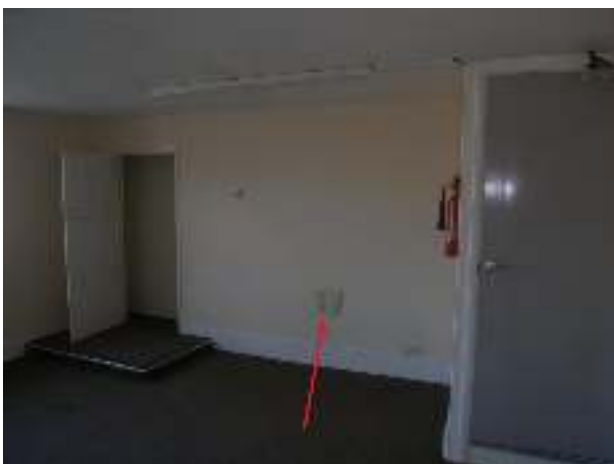
Removing the old party wall gave the middle front room access to the chimney running up beside the ground floor hall, enabling a fireplace to be provided (now removed – location arrowed).

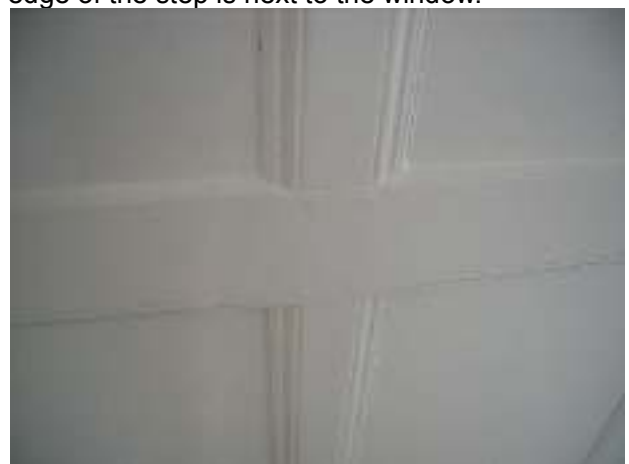
Close-up of door in left of previous picture – this was originally part of a full height panelled wall. The panelling is hand-made and could pre-date the building as currently comprised.

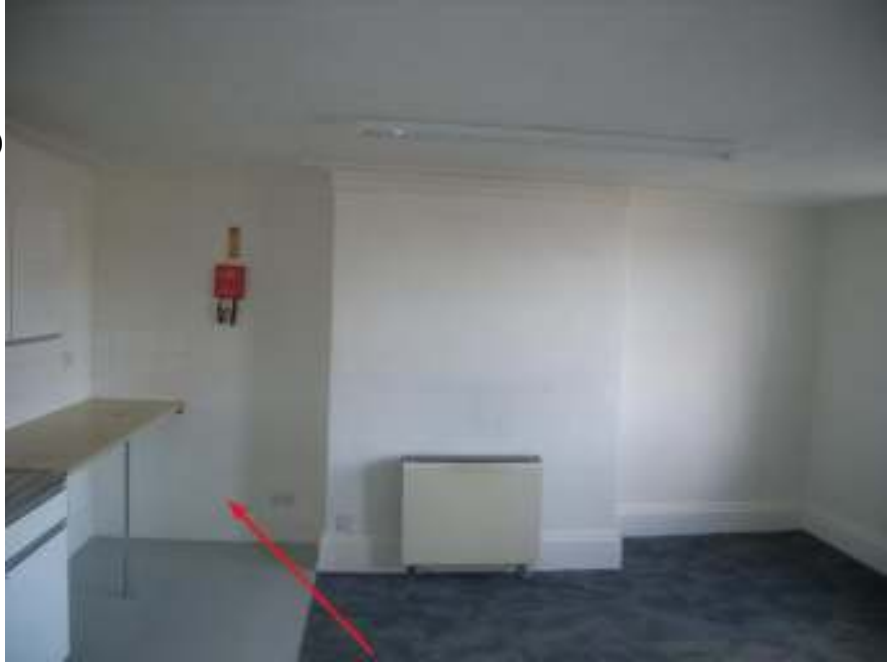
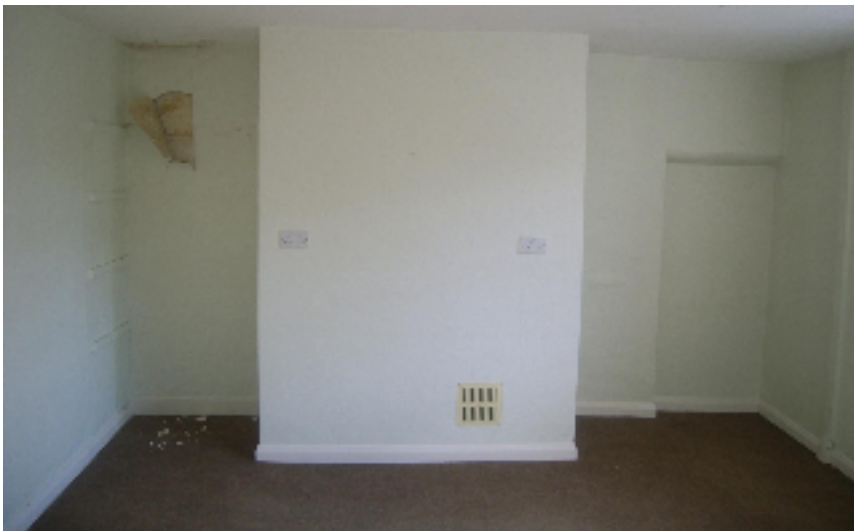
Like the room below it, the back room within the middle rear wing (see picture on left), has the very deep alcoves typically associated with circa 1800 chimney breasts. The chimney breast is notably off-centre. By not centring the chimney breast, the resulting wide right-hand alcove has enabled a doorway to be created into the southernmost rear wing – now blocked off but still clearly visible.

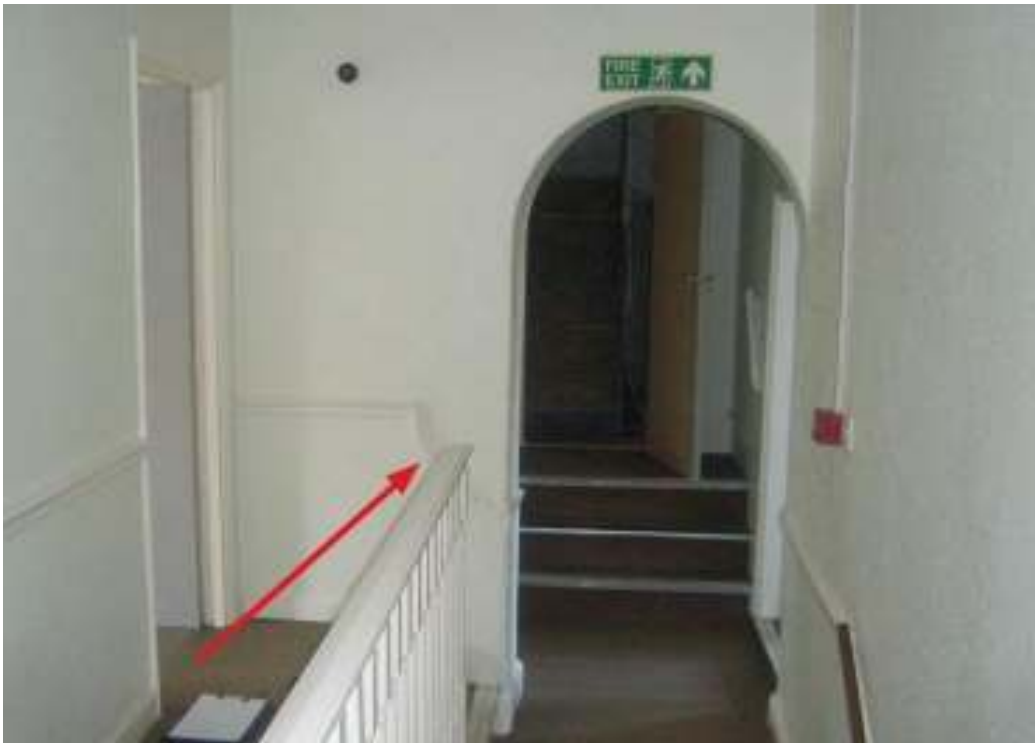
Note how carefully the chair rail (arrowed) has been curved to take account of the level change on one side at the top of the stairs. It also continues through the archway at the top of the stairs – the wall with the archway separates the middle wing from the northernmost wing. The continuation of the chair rail through the archway indicates that some sort of northernmost wing already existed when the middle wing was added i.e. a northernmost wing was present prior to the construction of the late 18th/early 19th century middle wing.

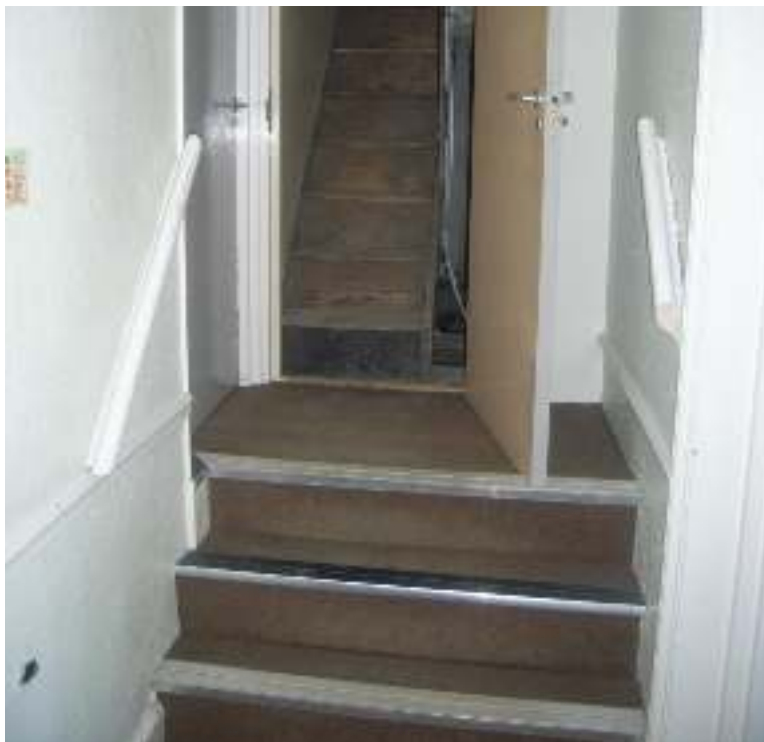
Where the chair rail continues through the arch, it runs at the same height as when it passed through the arch, ignoring the additional stairs and level change. This indicates the pictured stairs and current floor level within the northernmost wing are the result of a later reconstruction.

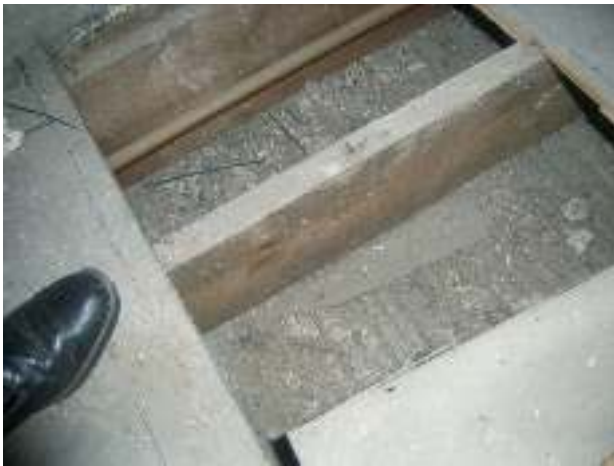
The floor joists are very narrow but deep. They support a plaster and lath ceiling for the rooms below but here is no bracing between the joists to stiffen the floor. This construction is typical of late 19th century work.

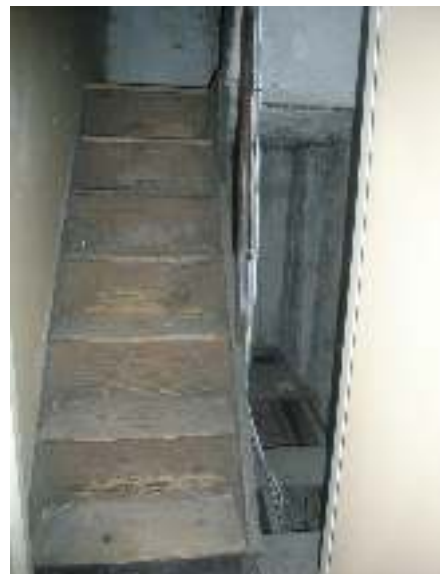
The simple but sturdy stairs could be anything from late 19th century through to about 1920. The amount of wear on the treads does suggest late 19th century is more likely.

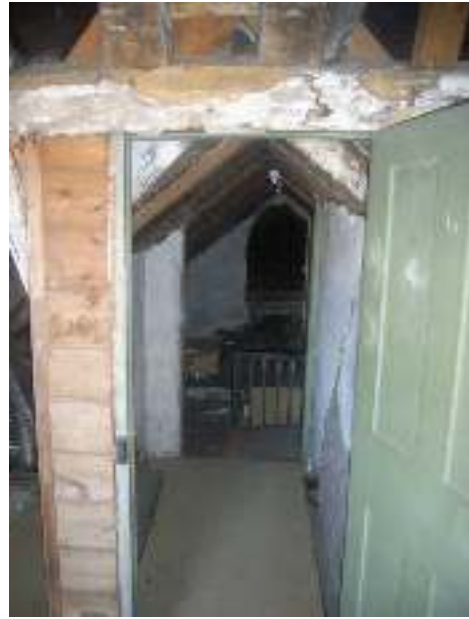
View back through 'tunnel' to the landing with the opening into the roof space of a rear wing beyond.

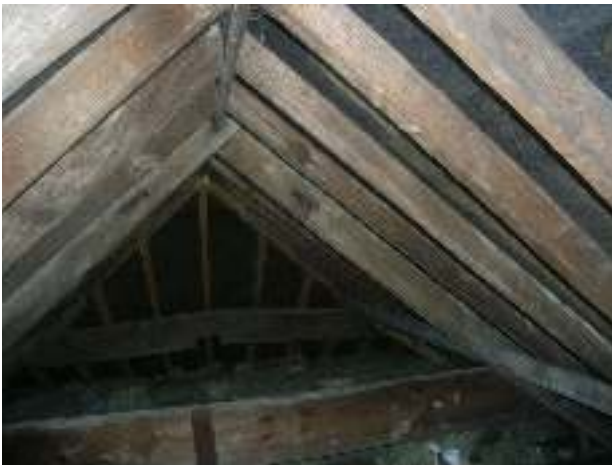
The roof space over the northernmost wing seems to be a hybrid of three different periods. The roof appears to have been reconstructed in the late 19th or early 20th century but reusing some of the main structural components from an early to mid 19th century roof. In the adjacent picture, the entire end section (furthest from the camera) dates from the late 20th century.

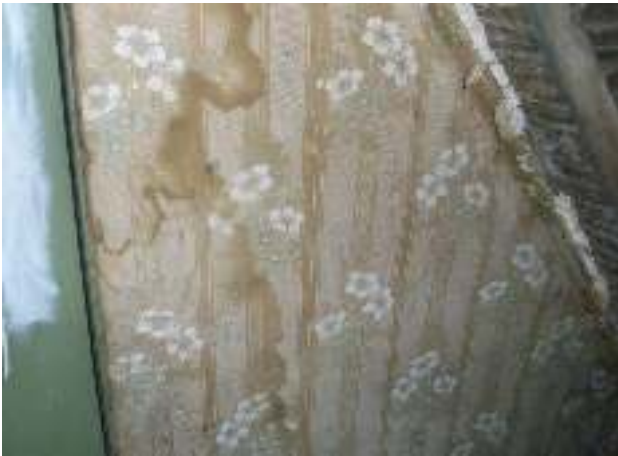
Now faded wallpaper – each bunch of flowers contained 3 white and 2 blue flowers. The pattern is typically 1920s and suggests the rooms were no longer used as bedrooms after the 1930s.

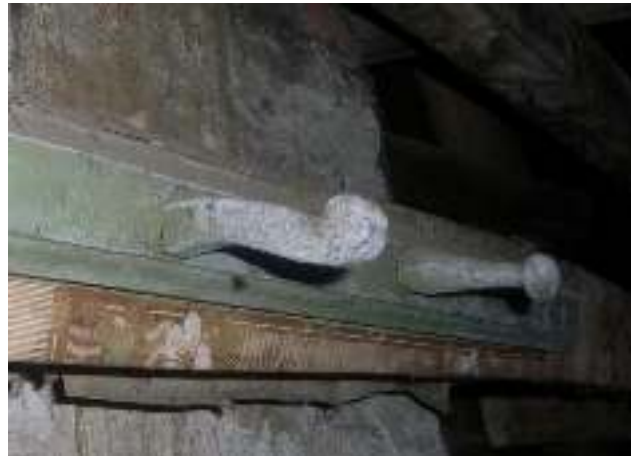
Long board with coat pegs mounted on it possibly dating from around 1800 – the far peg is one of the originals, the near peg is one of several that were renewed around 1900.

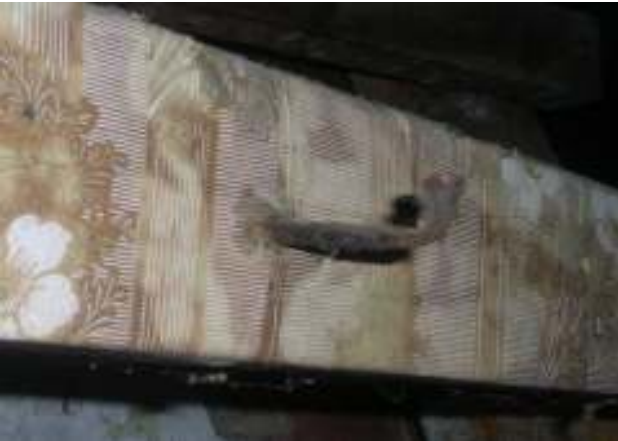
Some iron coat pegs have been hammered into the timber to the right of the coat peg board to increase the number of pegs available. Difficult to date but probably mid 19th century.

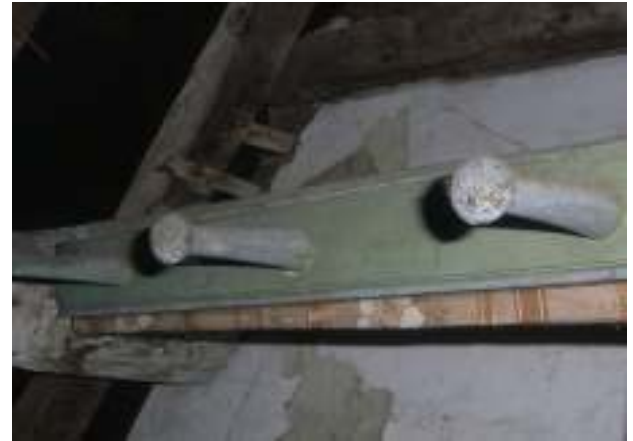
An additional board with another 4 coat pegs was fitted to the left of the original board, probably around 1910. Interesting that the maker reverted to a simplified version of the original peg design rather than use the fancy scroll design of about 10 years earlier.

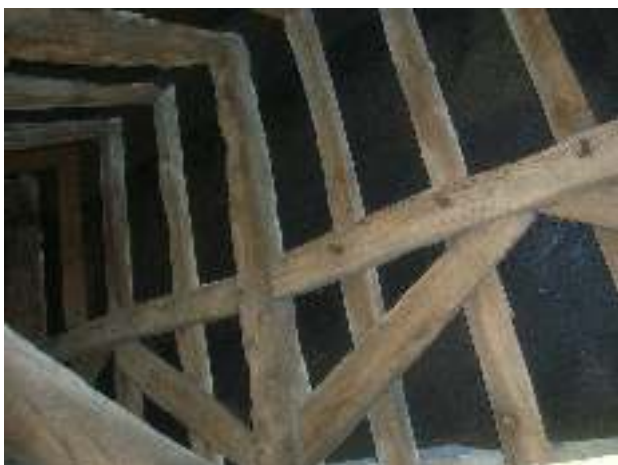
The main roof structure covers the section of the building with the shop front. This area includes the middle and northern dormer windows. The roof is a well braced, pegged timber structure that could easily have been designed in the 17th century. Large timbers have been used throughout and a complete set of numbered trusses are present (I-V). Despite their impressive dimensions, many of the timbers are poor quality with large quantities of sapwood which has decayed – contributing to the need for extensive repairs in recent times. The scarcity of large section high quality timbers to realise a 17th century design, suggests the roof was constructed around 1700.

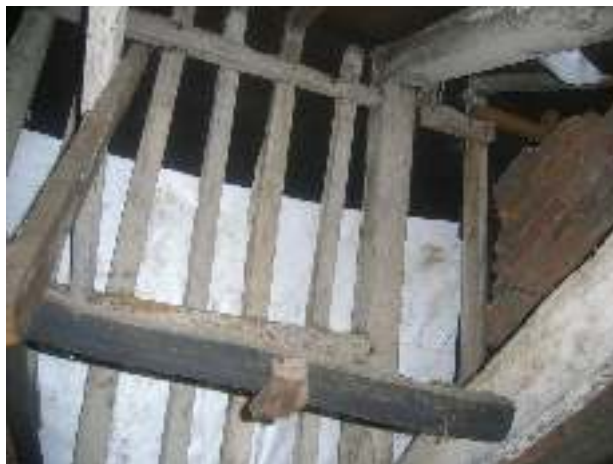
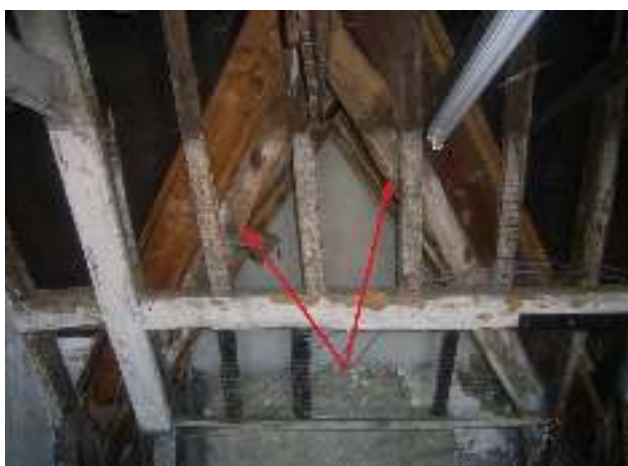
One end of the roof structure (arrowed in adjacent picture) over the southernmost rear wing (accessed from the adjacent butcher's premises) is visible just behind the roof section that comes through from the butcher's premises. Note how sturdy the timbers are and how much steeper the roof is compared to the areas next to the Market Place. This most probably pre-dates the 18th century and started life as a thatched roof.
